Chasing Water with Thermal Imaging

Peter Hopkins, Level III Thermographer
SoCal Infrared

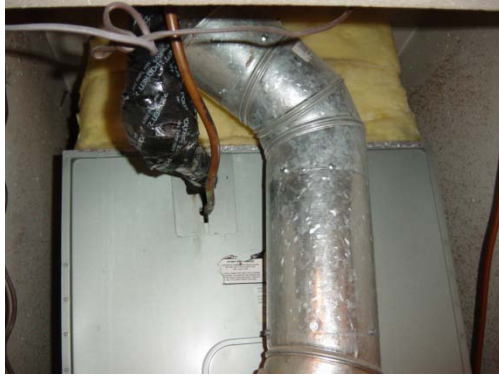
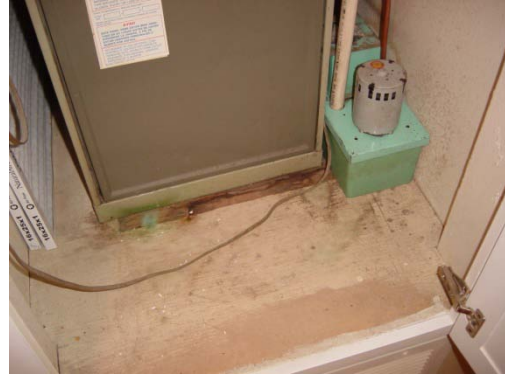
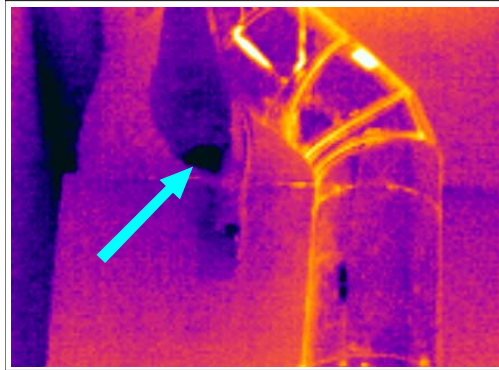
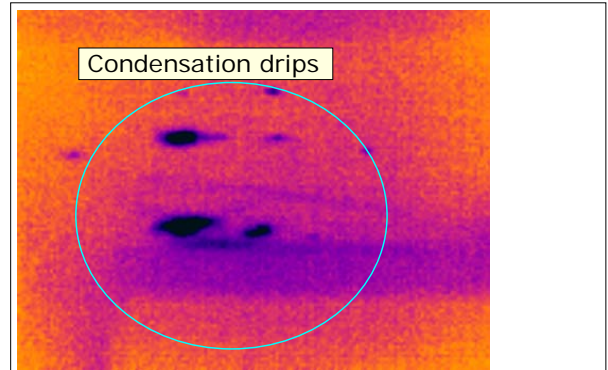
Figure 3. In the images above, water was condensing on and then dripping down from the refrigerant line down into cabinet. Thermal imaging helped map the leak to its source.

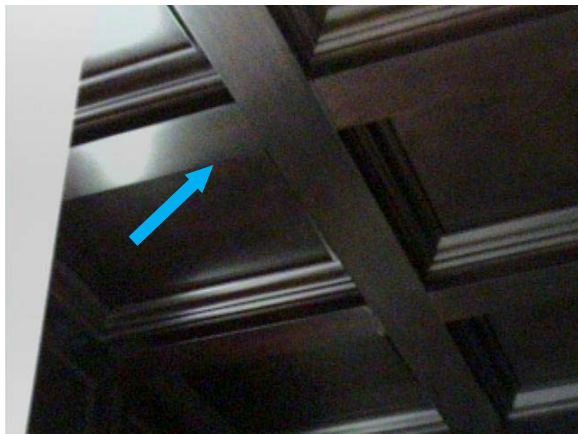
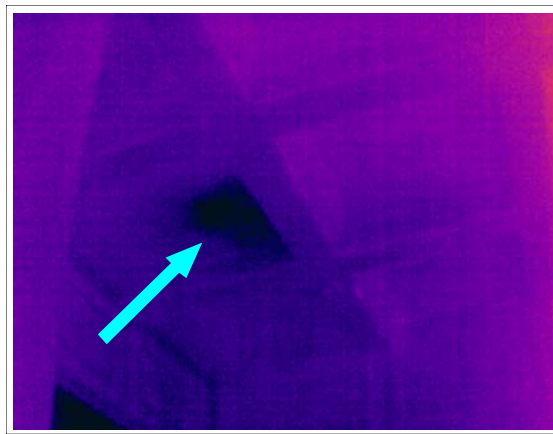
Figure 4. Thermal Imaging quickly identified the location of moisture; now it is up to us find the source of the leak.

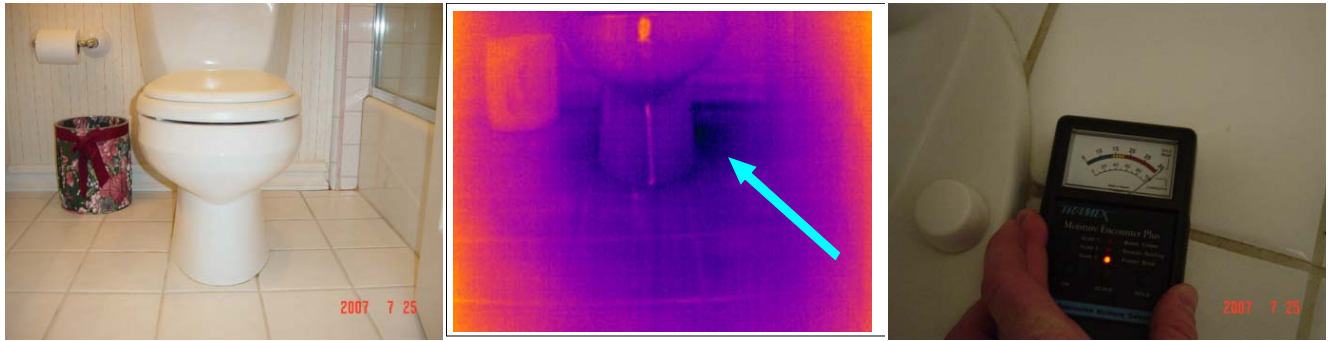
Figure 5. The room above the location of moisture damage was quickly viewed with a thermal camera and revealed a colder area at right side of toilet. When read with a moisture meter, this area was found to have 100% moisture. For comparison, the left side of toilet showed high as well, but the center of bathroom showed 0%. Thermal imaging helped to diagnose the leak's source: a failed wax seal and loose bolt on the toilet.

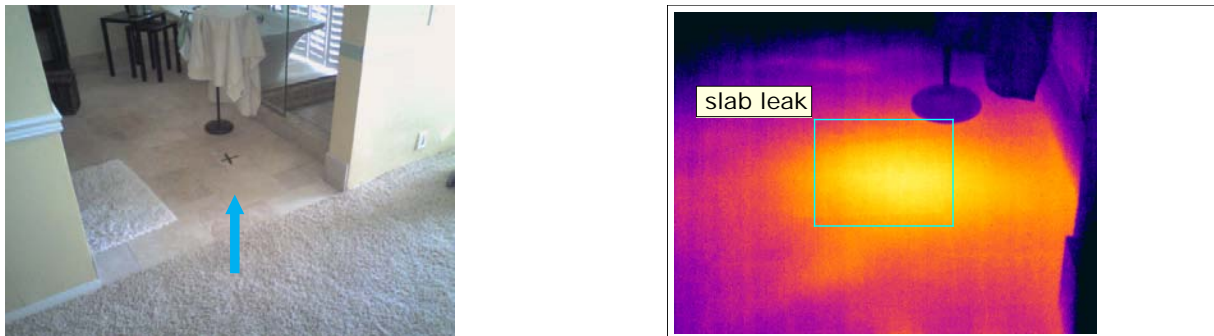
In the case referenced in Figure 6, ultrasound had failed to find the source of the leak, but infrared technology quickly brought the problem area to light.

Figure 6. As you can see in the image, "X" marks the spot

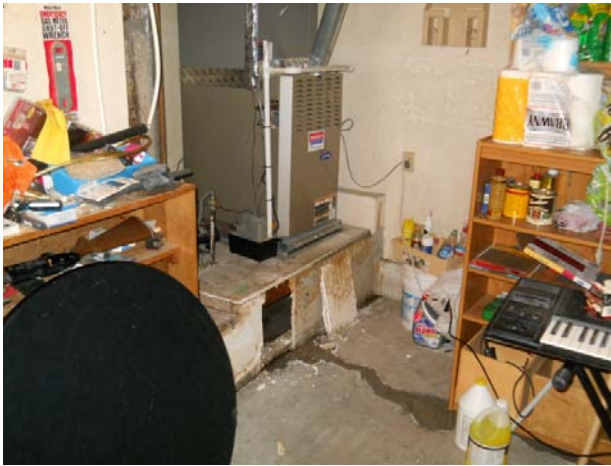
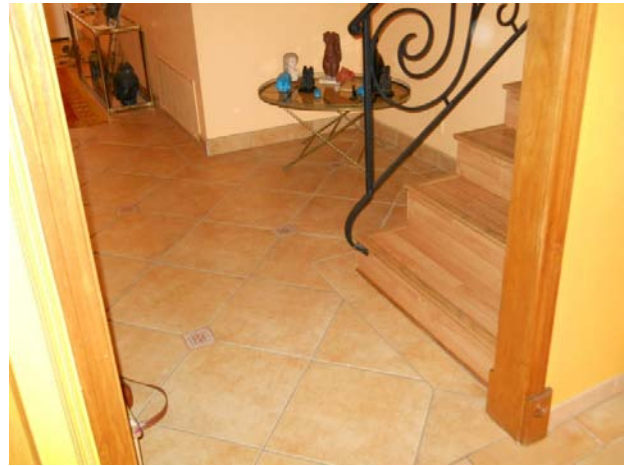
Figure 7. A definite leak is shown at garage floor. The opposite area in lower hallway showed no sign of leakage or damage anywhere.

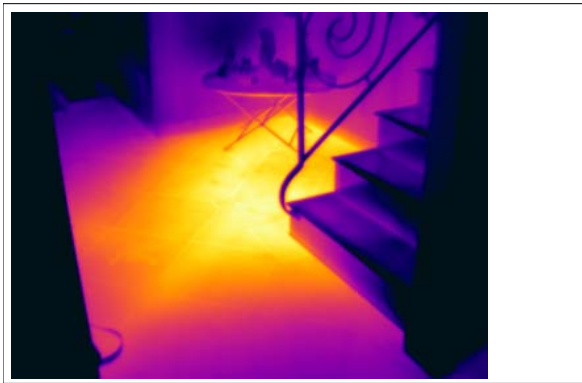
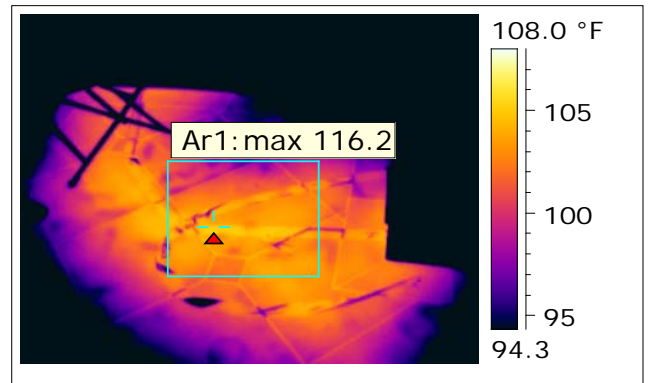
Figure 8. As you can see, a thermal picture is worth a thousand words.

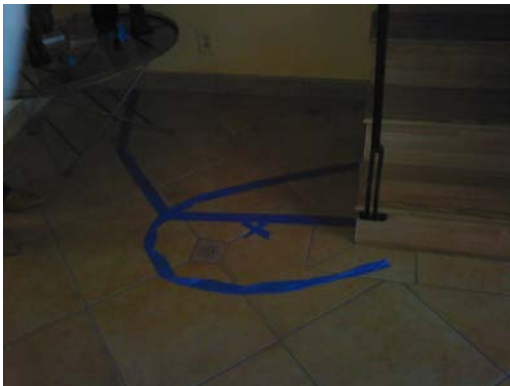
Figure 9. Through the use of thermal technology, we were able to map out a suspected leak location. As you can see in the picture on the right, the plumber is digging right at the "X".

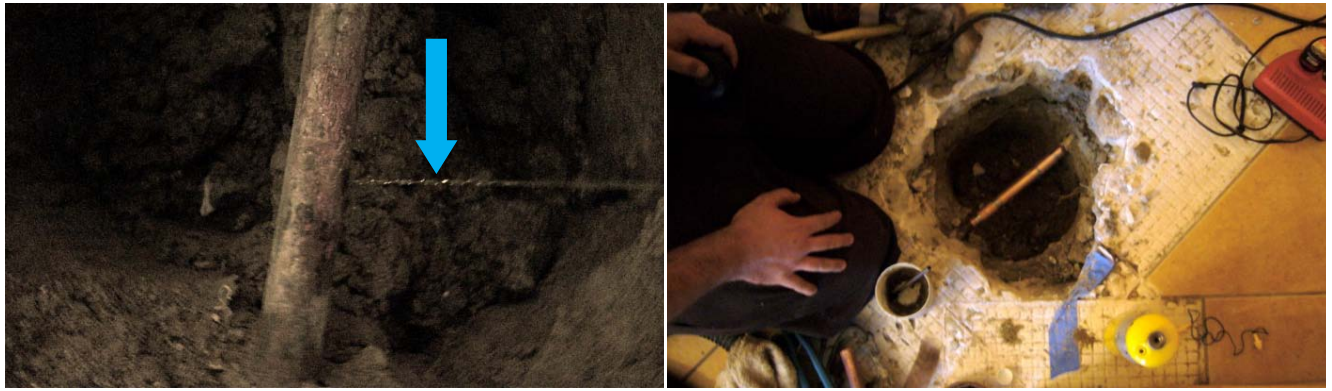
Figure 10. "X" marks the spot; in fact the owner of the home called me the next day to express how upset he was that I was 1" off. (I am being facetious if you didn't get it.) The picture on the right shows the newly repaired pipe back in order.

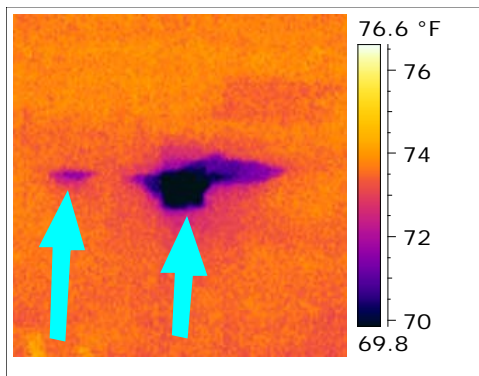
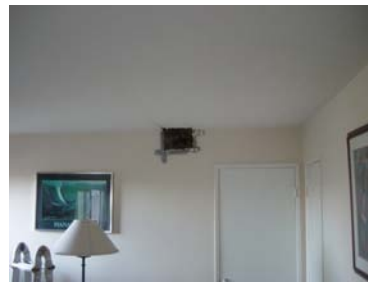
Figure 11. In thermal image on the left, there are two areas of moisture identified, not just one. The visual image to the right shows where client had opened up ceiling and found mold which prompted the call to us.

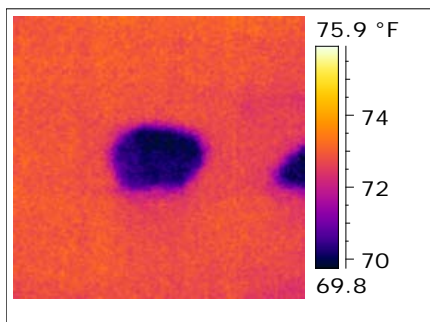
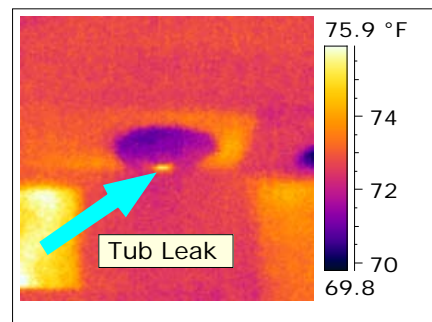
Figure 12. The second spot to left appeared independent of toilet leak (which had not been fixed as you can see). The tub was tested and imaging was done before/after tub was filled with hot water. As you can see in these two images with the time lapse noted under, we were able to confirm two leaks, not just one.

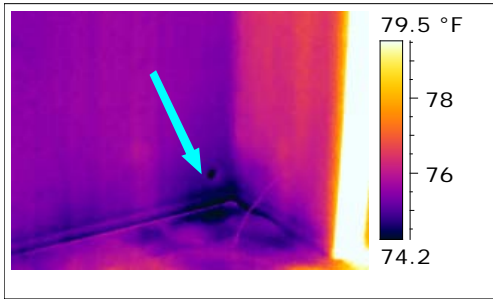
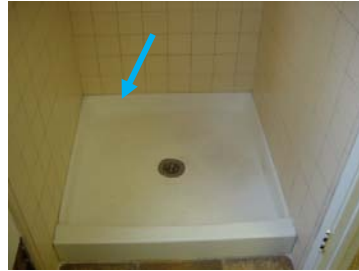
Figure 13. Left, thermal image from bedroom side showing evidence of moisture; right, visible image showing shower which is opposite. The arrow shows same location.

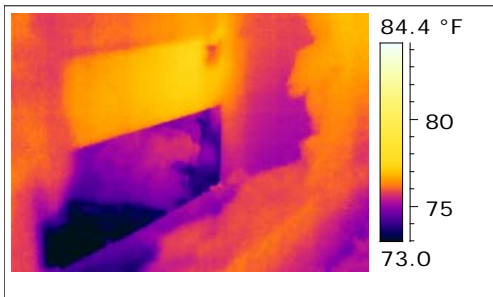
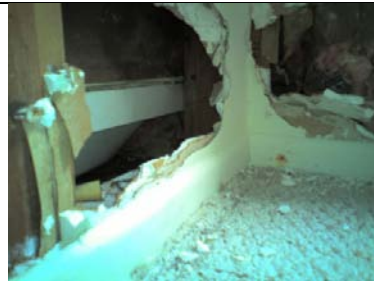
Figure 14. The wall was opened up to confirm the suspected leakage in the shower pan. Note: Dark area was wet at slab.

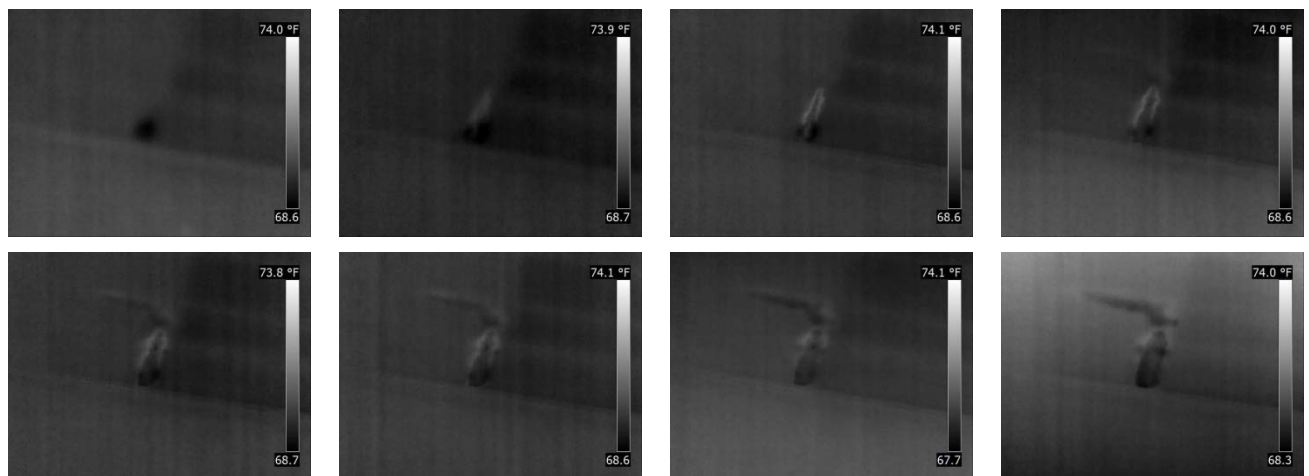
Figure 15. Time lapse thermal photo series over about 30 minutes of water testing.

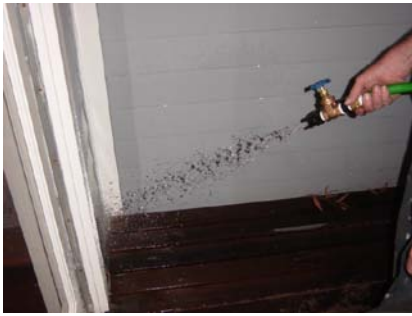
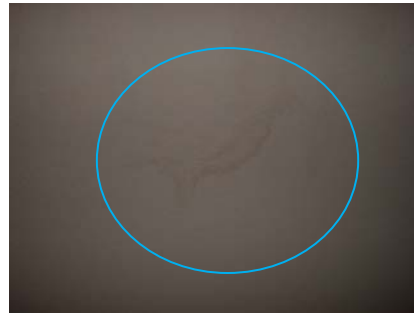
Figure 16. The stain in the image on the right was the final resting place of the water as seen in the last infrared image, but not near source, which was actually several feet away.

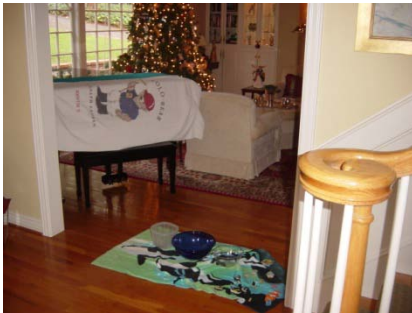
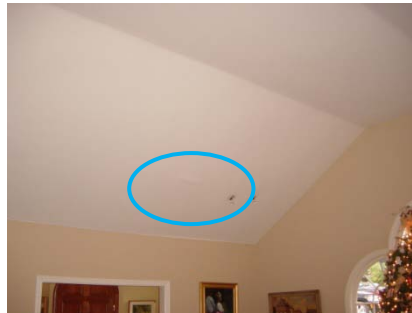
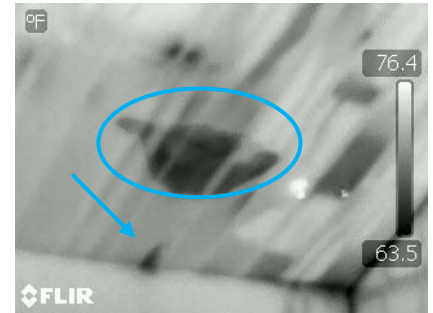
Figure 17. Left, visual image of leak (into blue bowl) centered in passage way between rooms. Center, visual image with circled possible water damage. Right, thermal image reveals wet area in ceiling. The arrow to lower left indicates how the water travels down the ceiling to the header wall directly over the catch basins.

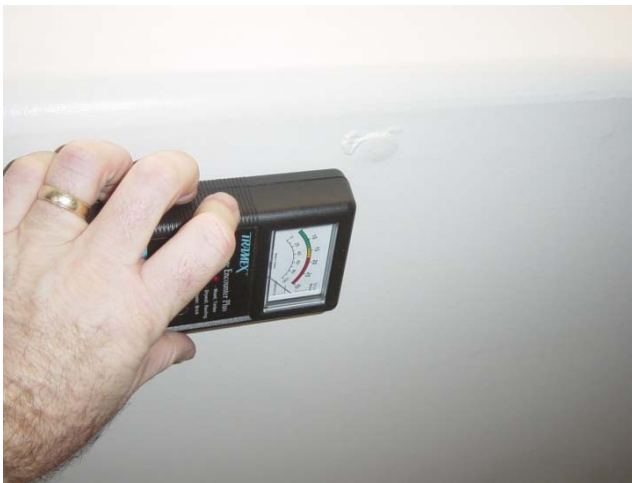
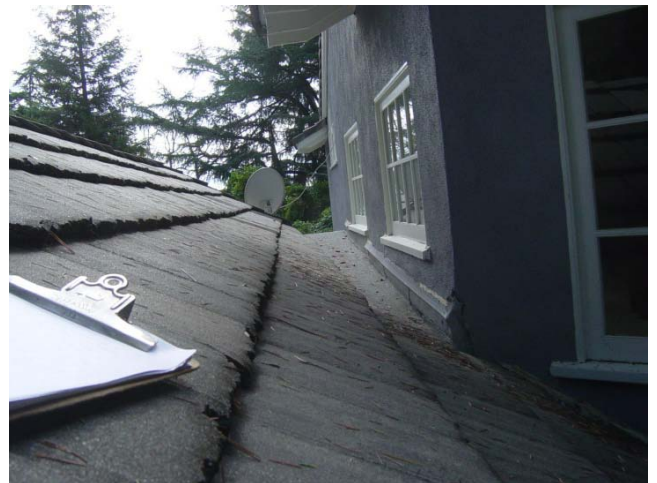
Figure 18. The wet area identified in thermal image was first confirmed with a moisture meter at 100% and then to the source. The roof had a steep slope with an upper roof cascading over, causing water to first hit the structure and bypass the counter flashing therefore leading to moisture entry. The suggested repair on this home involved a new design for a valley flashing versus the suggested roof replacement.

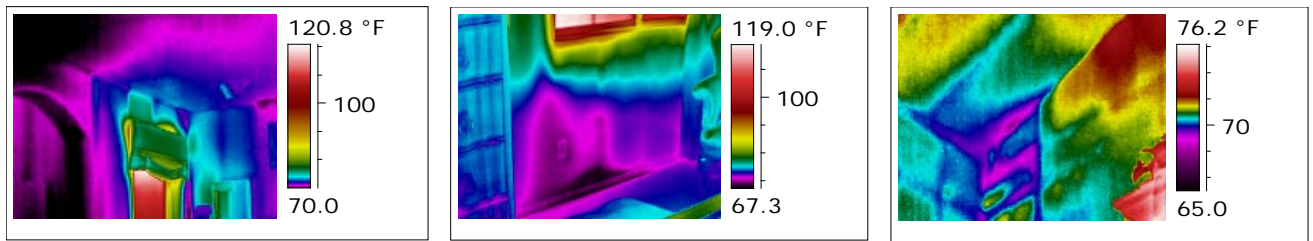
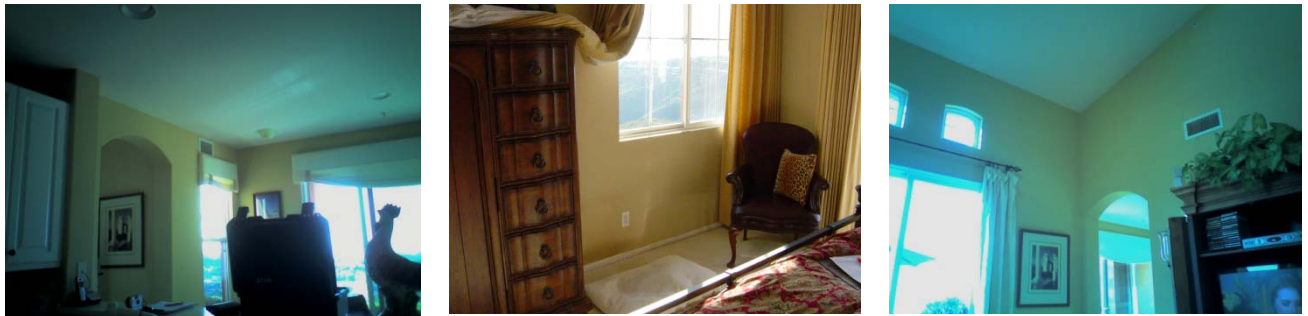
Figure 20. Top: thermal images showing the water damage in each of the rooms shown in visual images in bottom row.

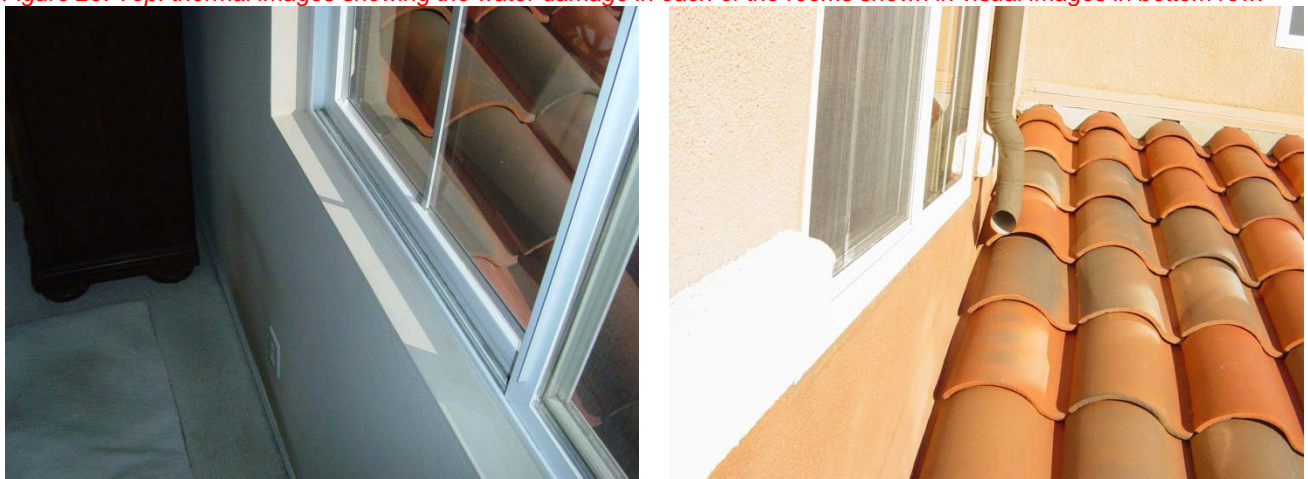
Figure 21. Upon review of the outside, it was found that the downspout from upper roof was directing a large amount of water against the side of the structure, bypassing the counter flashing and leading to water entry.

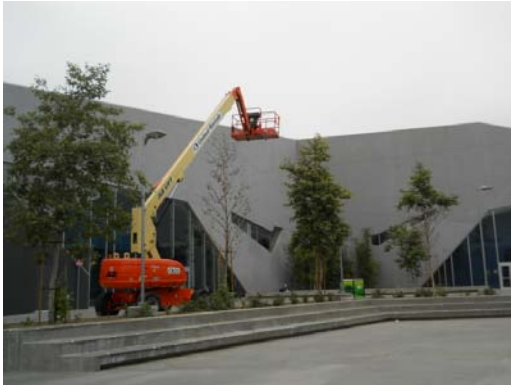
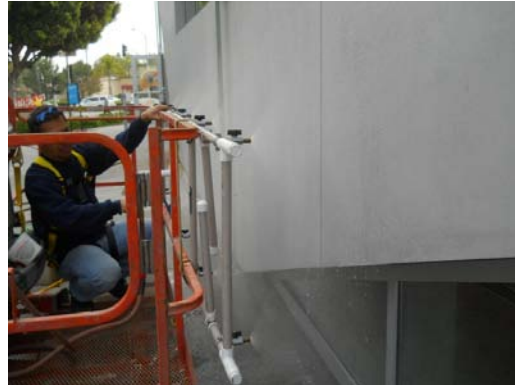
Figure 22. Leaks were found at three brand new buildings at this complex. The client had complained to builder of many leaks noted at windows.

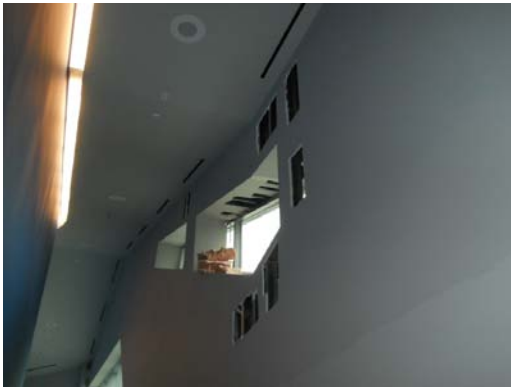
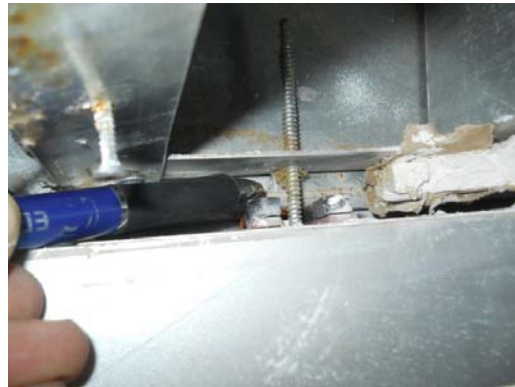
Figure 23. The frustrated builder had cut many holes in the walls in an effort to find the leak (left photo). Through our efforts, we were able to duplicate the leak, and as seen in the photo on right, determine the leakage just under window flashing.

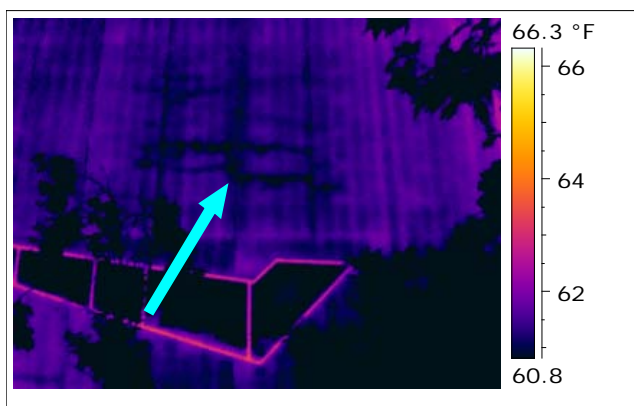
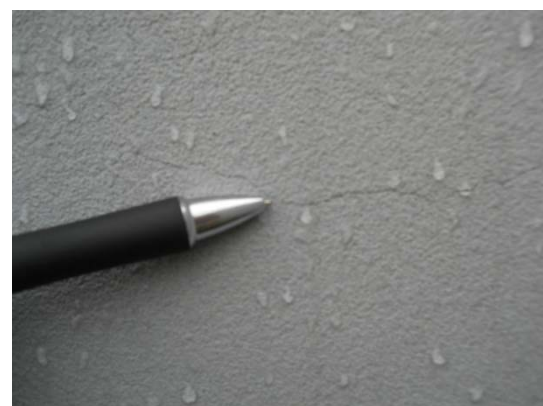
Figure 24. We now needed to locate the source of entry. Thermal imaging of the exterior of building quickly identified an anomaly which captured our attention. Upon closer look, we were able to confirm these anomalies were consistent with cracks in the stucco. As you can see in the photo on the right, the stucco finish was non-absorbent (acrylic finish). These cracks were actually breaks that allowed the point of entry. This collection of water and evaporative cooling are clearly shown in the thermal view. The fact that the finish of the stucco did not allow entry (except at crack) also meant it did not allow the trapped water to escape. Water simply took the path of least resistance and bypassed the window flashing to enter the building. Case solved!

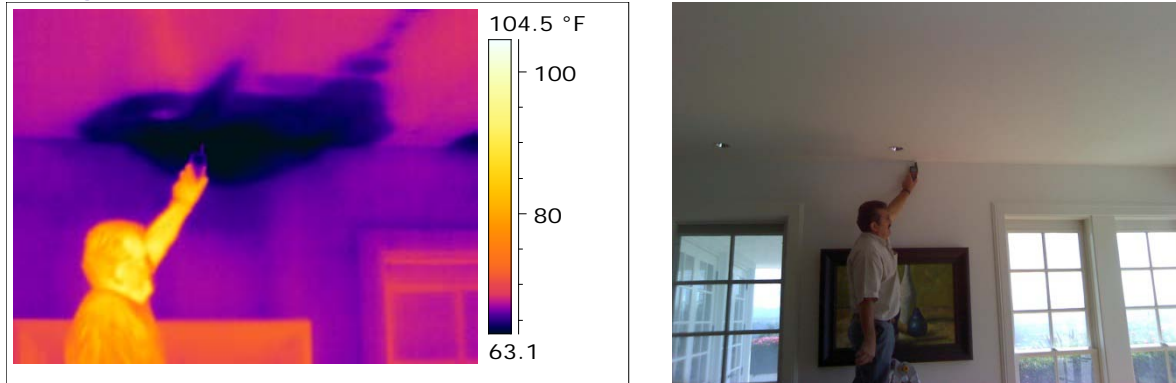
Figure 25. My company was retained after a failed attempt to identify the source of a leak. As seen in the thermal image, the moisture is still there!

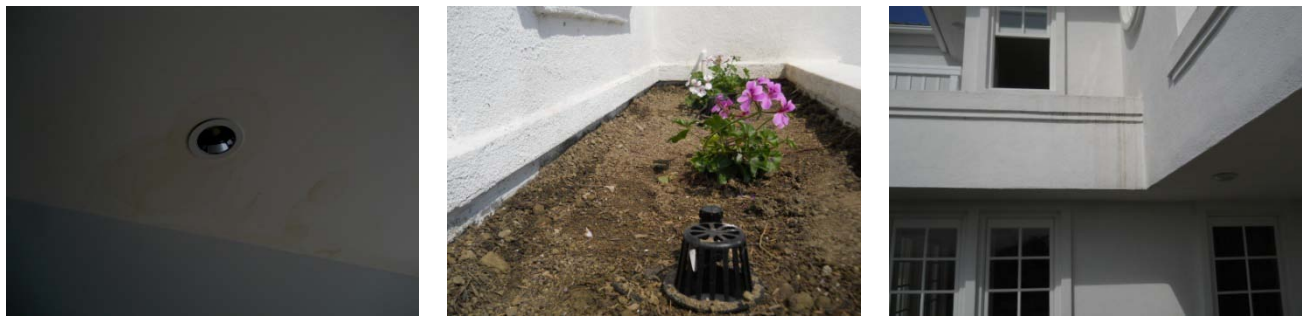
Figure 26. The living room of this large custom home showed a leak at the ceiling corresponds to a planter on the exterior of the building as seen in the center image. The right image is the outside view that corresponds to the thermal image in Figure 25 of the gentleman taking a moisture reading. The contractor completely removed and re-waterproofed the planter, believing the moisture was a direct result of the proximity of the planter. The ceilings of living room and adjacent room were all repaired. However, with the next rain, the same leak reappeared.

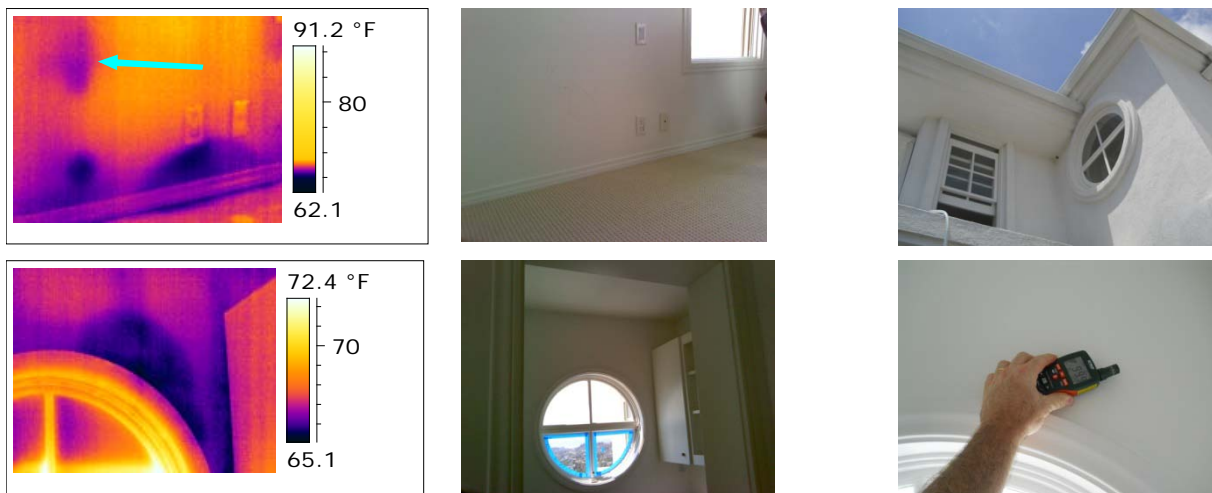
Figure 27. Thermal imaging of the walls showed us the water extended above the planter (top left image, blue arrow and at adjacent bedroom above round window).

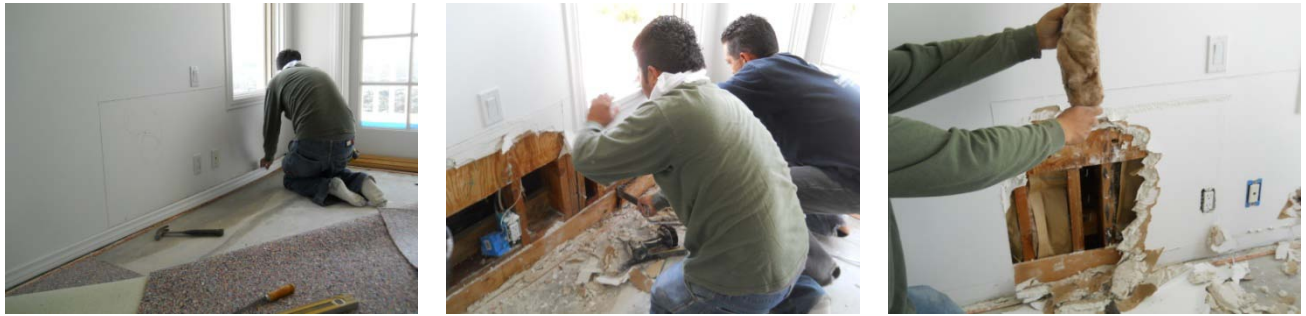
Figure 28. Destructive testing confirmed what the thermal imaging had indicated as drenched insulation above planter. Notice the worker wringing out water from insulation taken from wall.

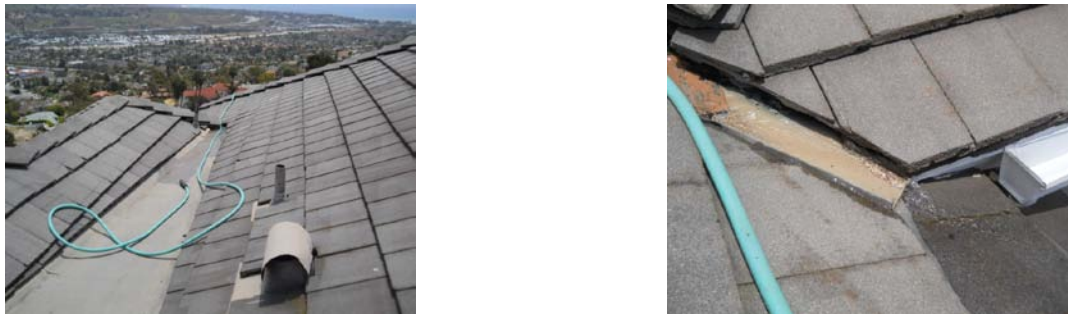
Figure 29. Our attention was now directed toward the roof with water testing. While on the roof and focusing our efforts on upper areas, we identified what appeared to be a new gutter system installation. When the contractor was questioned on this, it was determined that the gutters were installed just weeks before the initial water damage manifested.

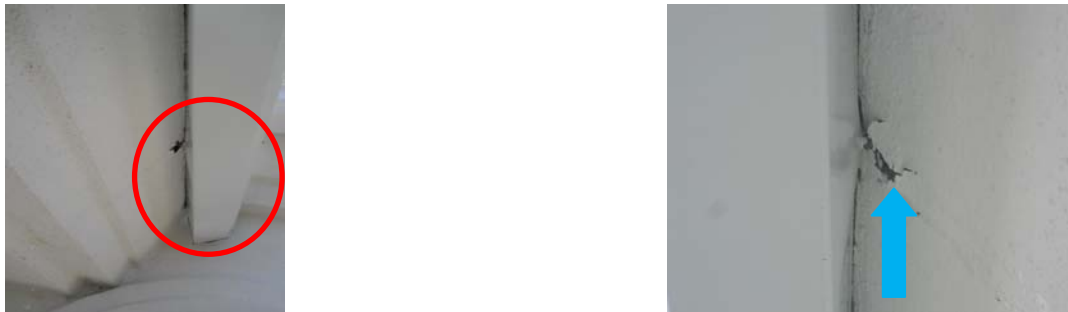
Figure 30. It just so happened that the water flowing from roof hit the splash block at gutter, passed back to supporting nail at gutter, and exited around the nail, entering the structure at the soffit.

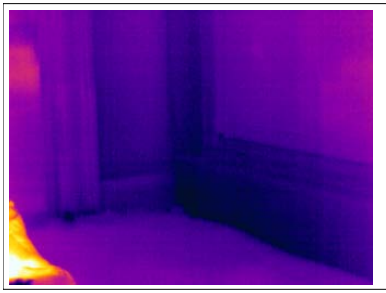
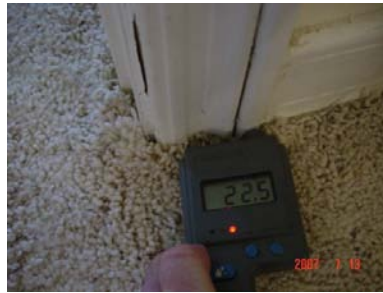
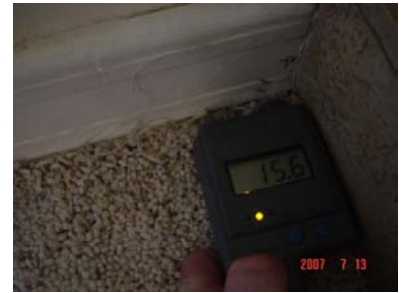
Figure 31. Client's complaint was that the shower leaked, but the shower had not been used in over a year. Thermal imaging in combination with the use of moisture meters confirmed elevated moisture at corner of wall (rather than close to shower as would be suspected).

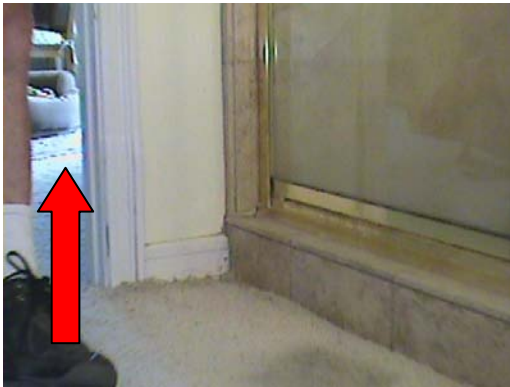
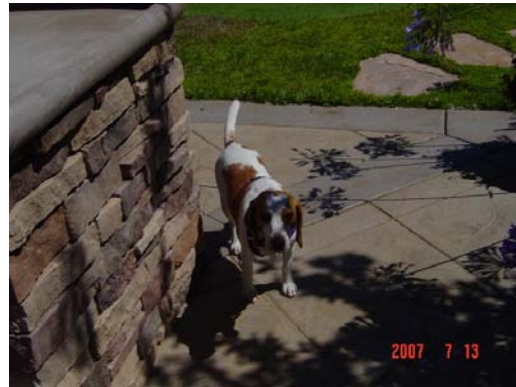
Figure 32. Well, we finally had to use another meter (our noses) to determine the source of the problem was not what the owner expected. Notice the arrow on left (dog bed) and the guilty party in the right image.
