Demystifying the Art and Science of Finding Moisture in Buildings using Thermal Imaging

***By Peter Hopkins, Level II Thermographer
United Infrared, Inc.***

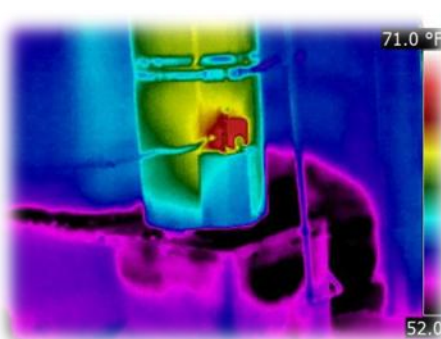
Leak at a water heater

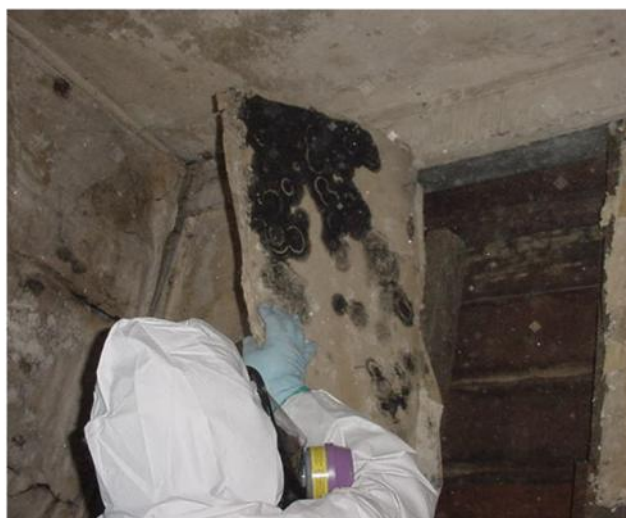
Mold damage

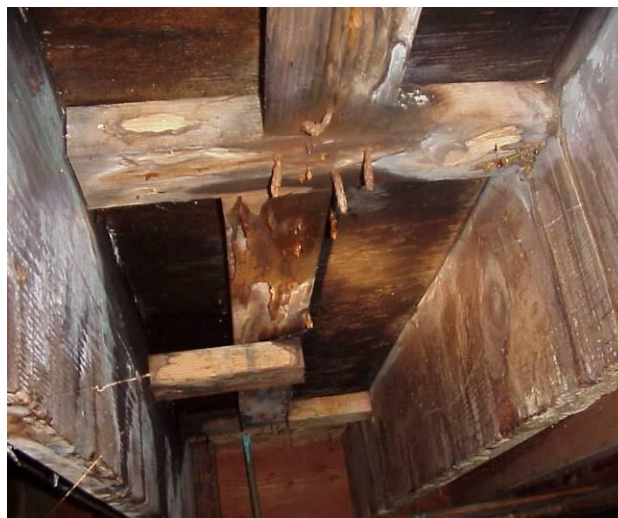
Subfloor damage due to leak

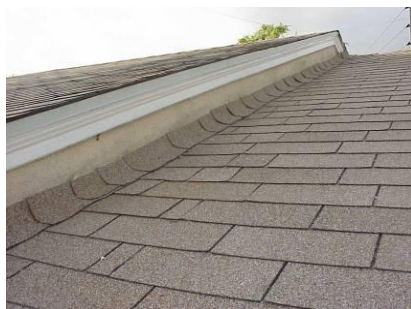
Roof with no proper counter flashing

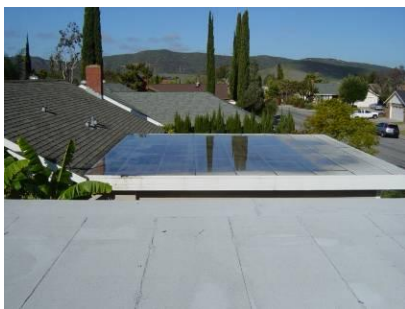
Roof not pitched properly to drain (holding water)

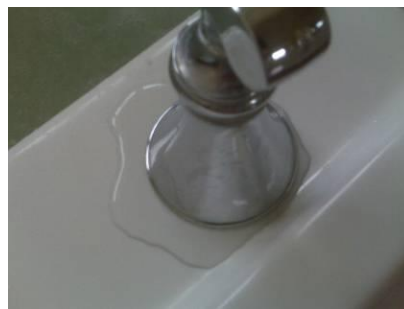
Plumbing fixture leak

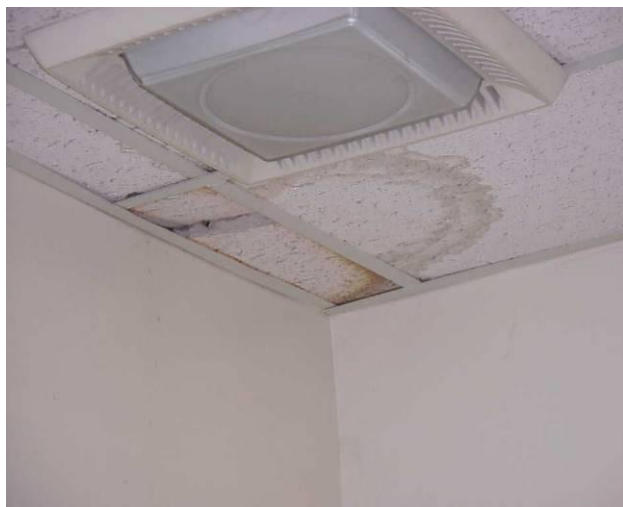
Ceiling stain

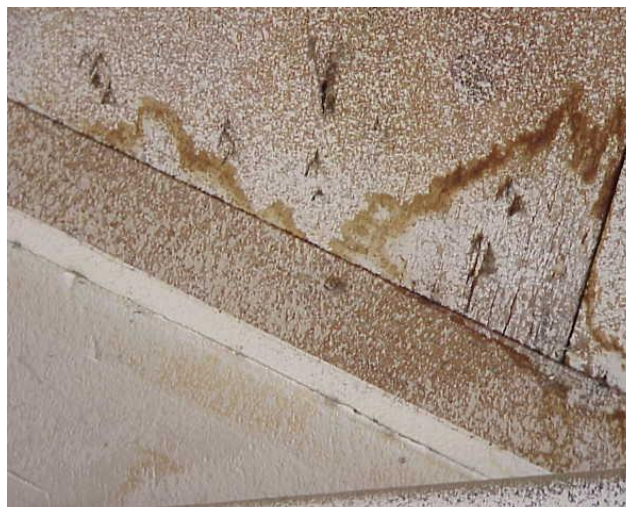
Stain

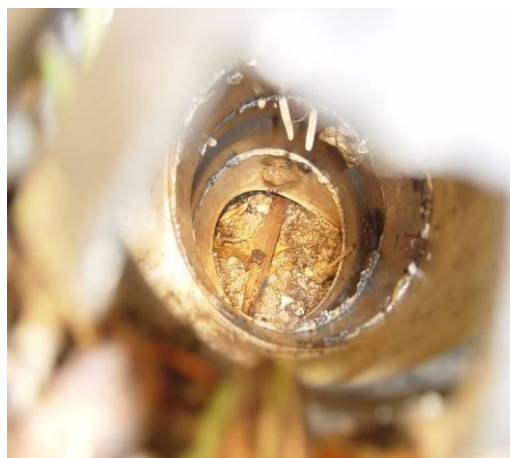
Upon review of the exterior and moisture mapping the interior of the unit, we were able to identify the root cause of the moisture: The exterior drainage system was improperly designed and was clogged at the time of the inspection causing leakage and excessive water at foundation. The soil was allowing water to build up against the structure and the waterproofing was failing.

Clogged Drain

As additional waterproofing would be difficult, it was our recommendation to properly repair the grade of the home, clean the drainage, install gutters and consider hardscape next to the home to minimize future moisture intrusion. This, of course, in addition to remediation of the wet areas.

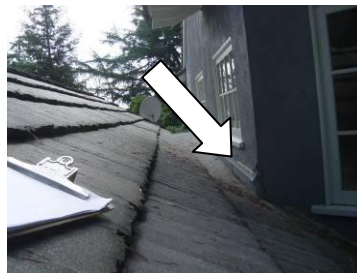
It turned out the suggested roof repair by local roofing contractor would not have solved the problem as the true issue was poor roof design of the flashing detail as you can see in the image (D).

In heavy rains, water from the upper roof cascaded onto the lower steep-pitched roof, where it was directed against the building and under the poorly designed counter flashing on the wall, eventually finding its way into the living room ceiling.

(D) Arrow showing point of
water entry at flashing

Our recommendation was to install a new wide cricket flashing, taller counter flashing, and gutters on the upper roof to redirect the bulk of the water.

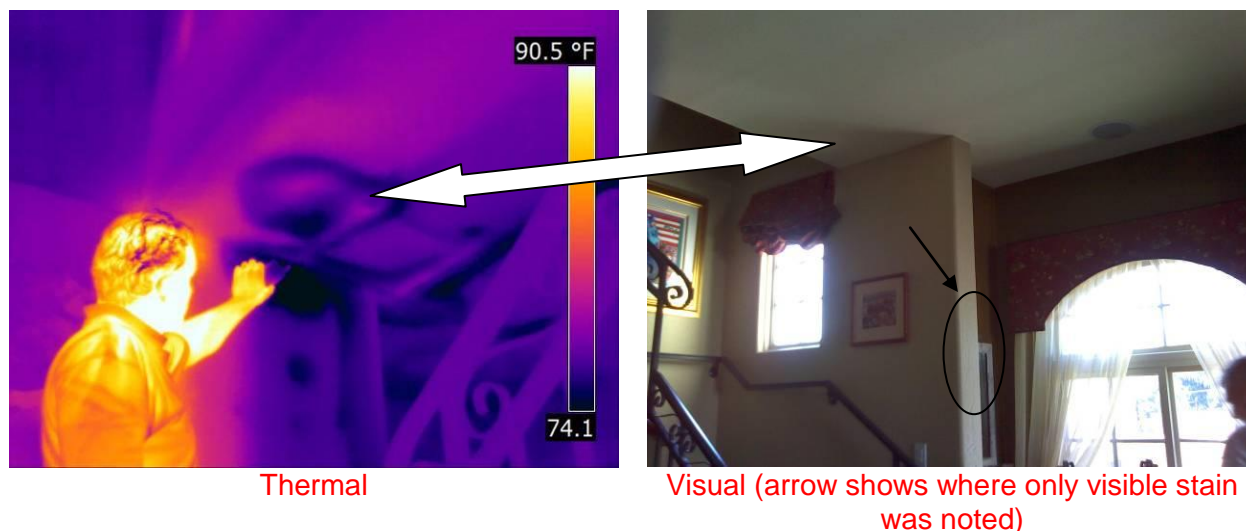
Upon arrival we did our normal routine and documented conditions and took moisture readings but when we turned on our infrared camera, we saw the true problem. There was no visible moisture at the ceiling but we quickly confirmed the wet area with our thermal camera. This led us back to the tub but we decided to confirm up our suspicions with a quick water test of the tub upstairs. We tested the tub with hot water and within minutes, we were able to see water coming down at the return wall.

We followed the moisture path and saw how that wall leads right back to where the tub drain is...voilà! case solved.

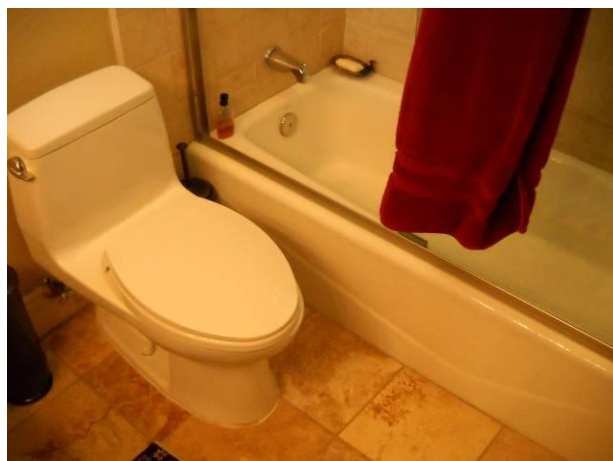
Bathroom above

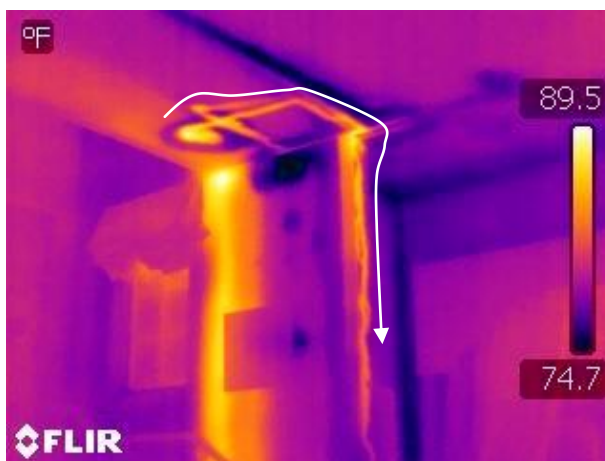
Water testing showing water travel

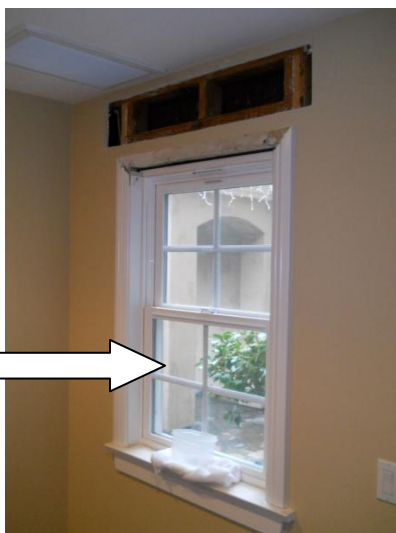
Interior View, Owner opened up portions of wall to find leak.

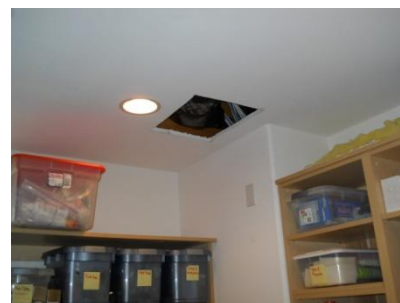
2nd story above bedroom closet suspected and owner cut holes in ceiling looking for source.

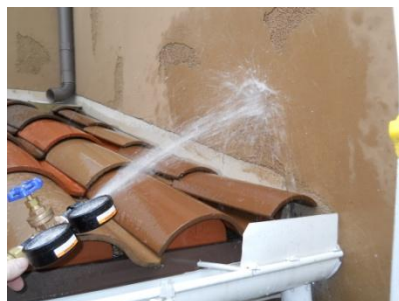
Water testing suspected area

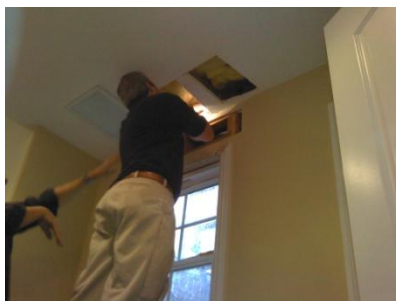
Cutting openings in ceiling

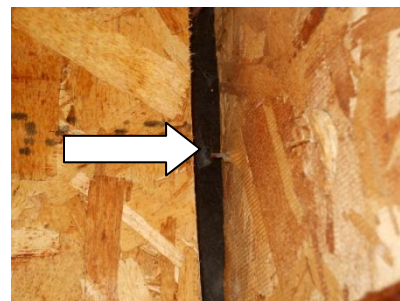
Visual showing nail penetration

Water testing of the residence at the lower suspected area and having opened up the ceiling allowed us to confirm our suspicions. It appeared that the contractor had penetrated areas of building paper which were allowing moisture to come into residence. Although they had come at previous times to repair, as mentioned earlier in this paper, it is only a matter of how much water had to saturate the stucco before it would appear and in this case....5 minutes of water did the trick.

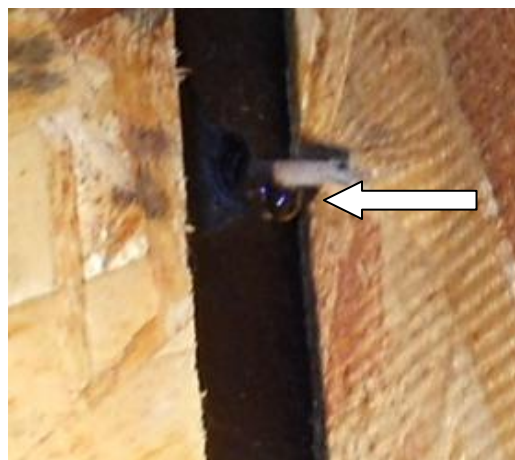
Close up of nail with drip
