From Houses to Horses

*Peter Hopkins, Certified Thermographer
SoCal Infrared (www.socalinfrared.com)*

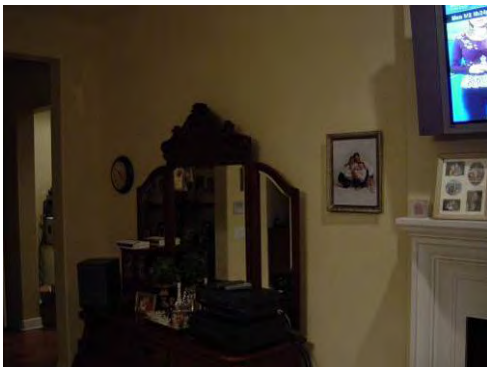
The first case: "Energy Leaks" Insulation Verification

Figure 2. Visual image of missing location.

If you would like to know why the middle of the wall was missing insulation, look up the reference at end of this paper.

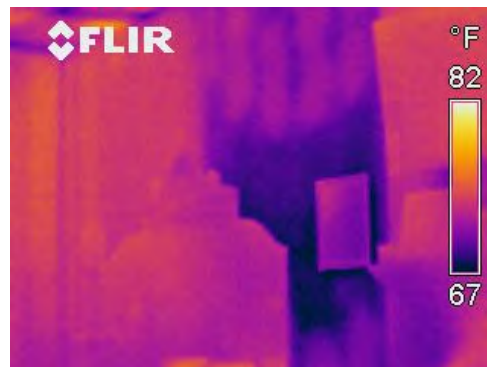
Figure 2a. Thermal image of missing insulation

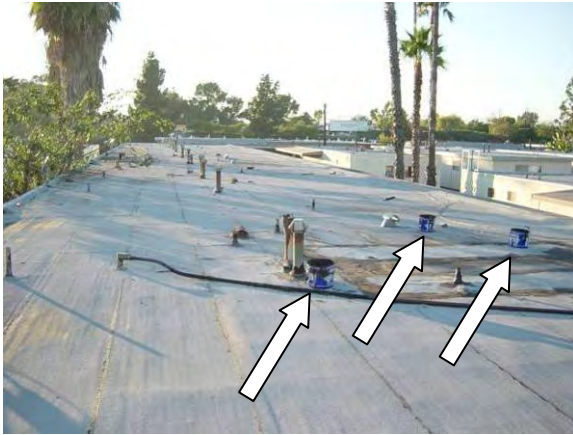
Figure 3. Roof with problem spots.

You probably know there is a problem when you arrive on the job and find five cans of roof repair left on top of the roof. What was most interesting was that these patches didn't address the water intrusion, but actually sealed it in to create another problem that was more costly to repair. An initial infrared scan would have shown the building owner and roofing repair contractor exactly where to repair or replace the roof. Roof scans appear to be a much larger opportunity than what appears to be used our market today. It is only a matter of time before the awareness in the commercial market fully recognizes the benefits of infrared. I hope to expand this paper in time to include from Houses to Horses, from “Roofs to Hoofs.”

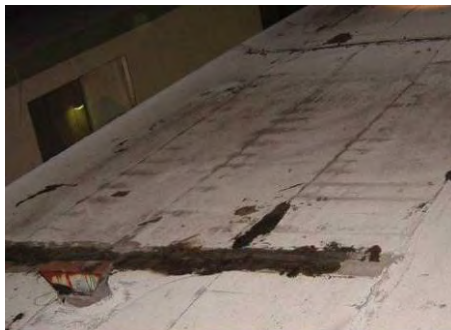
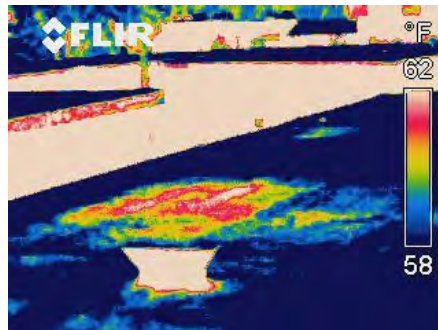
Figure 4. Visual of substandard roof patch *Figure 4a. Thermal image of substandard roof patch.*

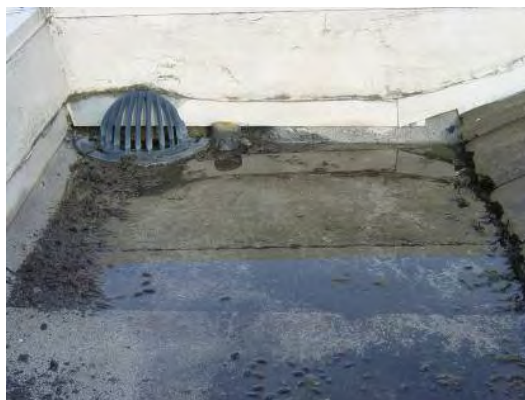
Figure 5b. Improperly installed drain allowing moisture intrusion.

As part of our service, Isolating the cause and delivering a remediation plan is our goal. Upon arrival at residence, the client described areas of concern. Upon review with a thermal imager, we were able to document the affected areas. Upon review of roof above affected area, water ponding was noted on the roof and a drain was installed improperly right through the parapet wall flashing. It was our recommendation to

properly adjust roof slope and to reconfigure and seal the roof drain. A secondary drain was present as well but was capped, which was just making the problem worse.

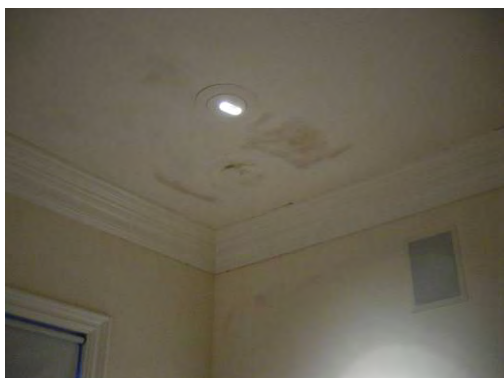
Figure 6a. Visual of water damaged areas.

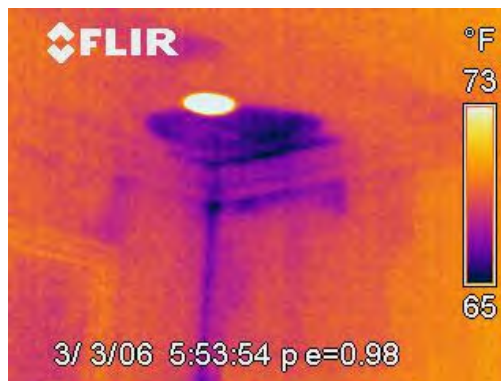
Figure 6b. Thermal images of water damaged area.

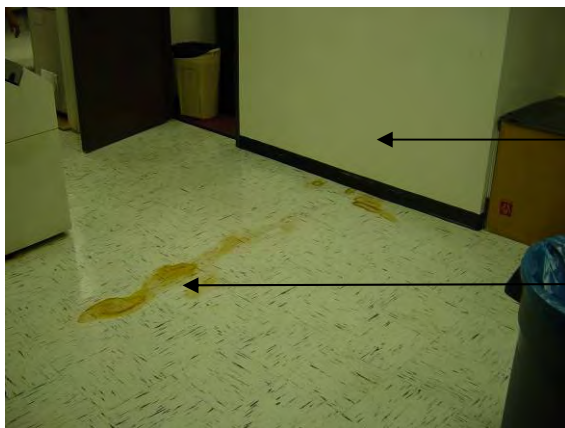
Figure 7a. Stains on the floor.

Midway through 2006, a large television based Christian organization heard about SoCal Infrared and our ability to isolate mystery leaks with Infrared technology. We were contracted as part of their effort to figure out why water was showing up in one of their buildings periodically. The tenant complained that several times a week, water was present at the floor in one of the rooms, and by afternoon, it was dry. As part of our investigation, we will ask what takes place in a typical day and night at the location. The building was being used for printing operations during the daytime. During evenings there were no workers except the cleaning crew that came through a couple times a week. Stains were present on the floor, as referenced in pictures below, but the surface of the floor appeared dry. The area was thermal imaged to map the moisture. Although the thermal anomaly was very light, it was enough for us to map the moisture and identify cause.

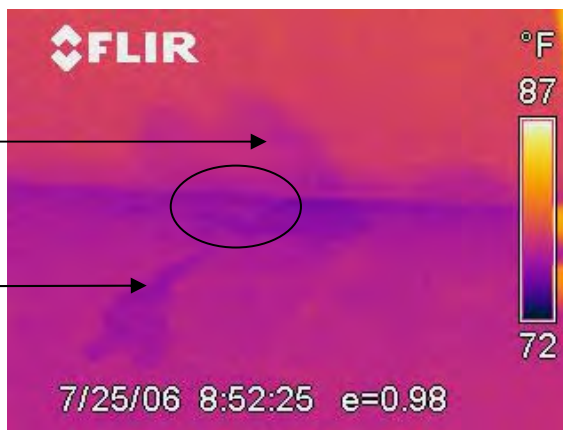
Figure 7b. Thermal image mapping of the stained floor area.

Upon review, a large stainless sink was noted at other end of room. Considering that water was a concern, I decided to run the sink for several minutes, after about 5 minutes, water was coming from floor (circle area at above thermal). This sink was not a regularly used area for the printing process, so this is why they had not seen this problem during the daytime. Building maintenance personal attended our inspection review and immediately started to remove floor tiles. Upon their removal a small hole was noted in floor that was opened further to expose a drain pipe that was not properly capped or sealed. Knowing that a properly installed drain will travel downhill, there should have not have been water traveling up a pipe unless there was some sort of clog. I advised them that a plumber should come in to snake line. A plumber happened to be onsite who came right over. Upon the snaking of line, mop strings were removed from the drain line (right picture below).

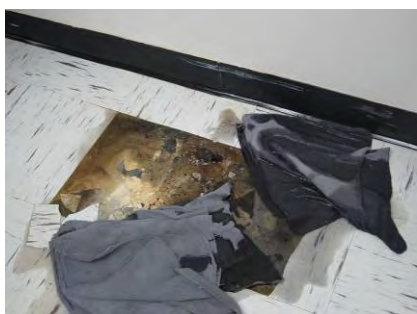
Figure 8a. Leak found.

Our investigation concluded that the night cleaning crew was utilizing the large stainless sink as their mop wash station and the mop strings had traveled and clogged the drain line hence causing the back up. Another satisfied customer, onto the next!

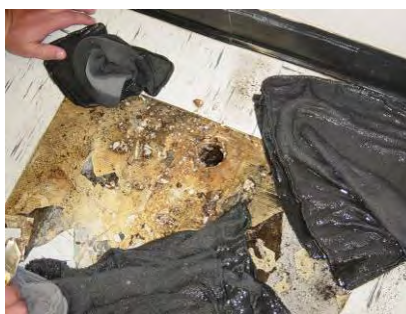
Figure 8b. Hole uncovered.

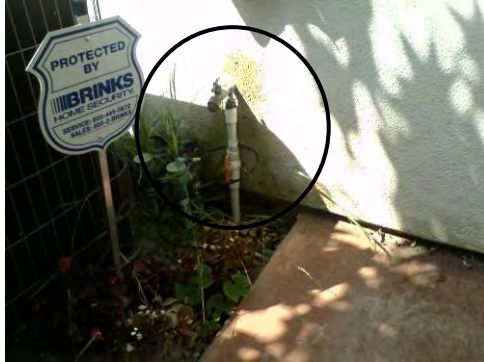
Figure 9a. Visual of pipe leak at stucco wall.

During a home inspection, I came across an area that had a plumbing supply leak and a drain line leak about twenty feet from each other, as viewed from exterior. Neither leak was known or disclosed by the home seller or agent. Obviously, the infrared confirms any suspicions and allows for the proper mapping of the moisture intrusion.

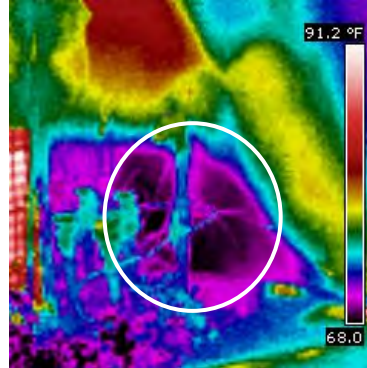
Figure 9b. Thermal of pipe leak in stucco.

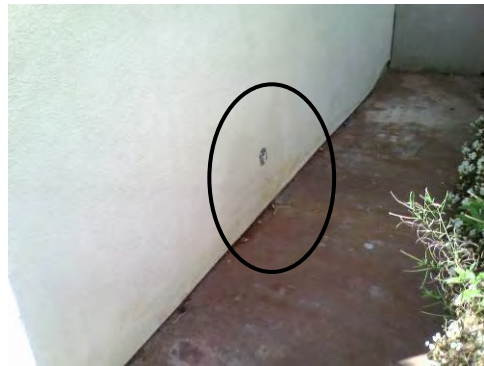
Figure 10a. Visual of sewer cleanout leak.

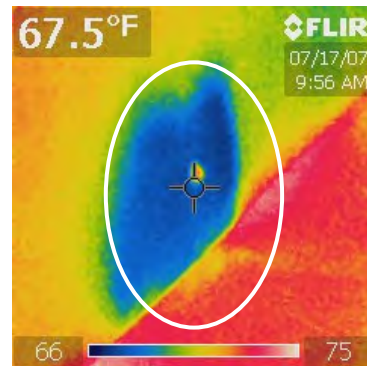
Figure 10b. Thermal of sewer cleanout leak.
